Protecting the Common Waters of the Great Lakes Basin
Through Public Trust Solutions

**RE: NEW EVIDENCE COMPELS STATE OF MICHIGAN TO ENFORCE EASEMENT VIOLATIONS
AND ELIMINATE CRUDE OIL TRANSPORT IN LINE 5 IN THE STRAITS OF MACKINAC**

Regarding Enbridge Line 5 Coating Condition and Related Observations

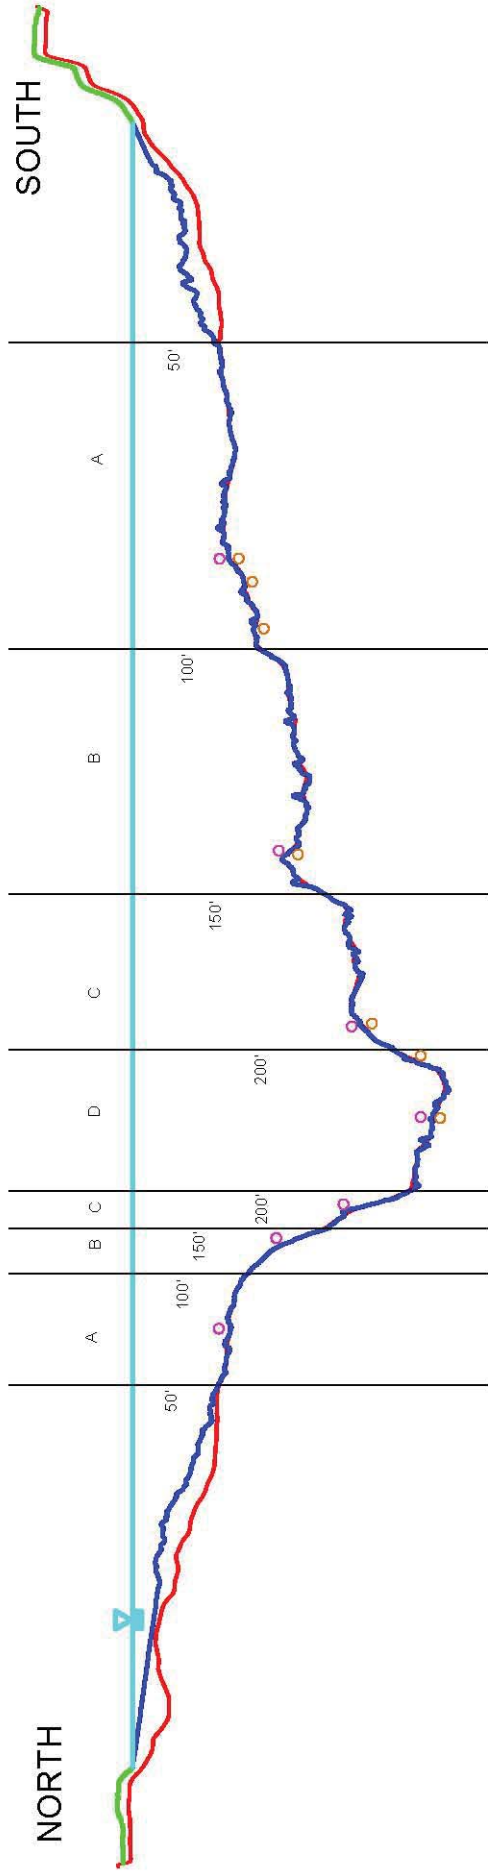
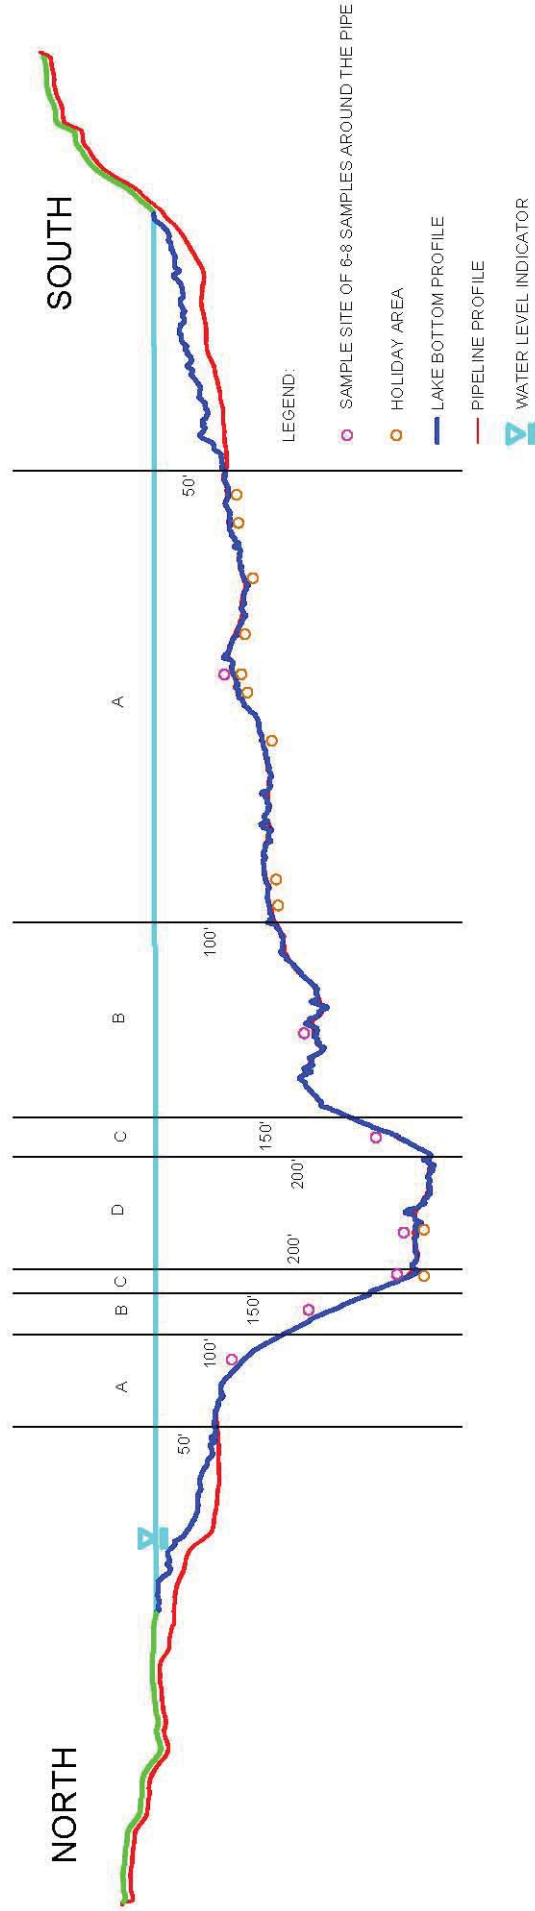
WEST PROFILE ZONES

EAST PROFILE ZONES

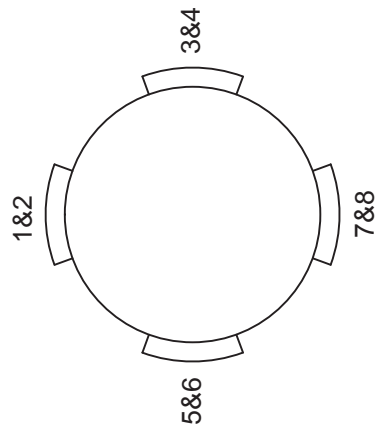
FIGURE 6: BIOTIC SAMPLER
(Design may change pending testing)

a fixed surface area on the pipe to enable quantification (number of mussels per square centimeter) of the total surface area sampled at each site. As noted previously, the containers needed to be compact so divers can effectively transport numerous containers, handle, and deploy them at depth within their limited dive times. The containers also needed to be neutral or negatively buoyant (somewhat heavy) so if accidentally dropped they would not float away in the current. Therefore, a device enclosing a surface area of approximately 100 cm² will be developed and used, similar to that used by Purcell (1996).

1. SAMPLER AREA SHALL BE APPROXIMATELY 100 CM²

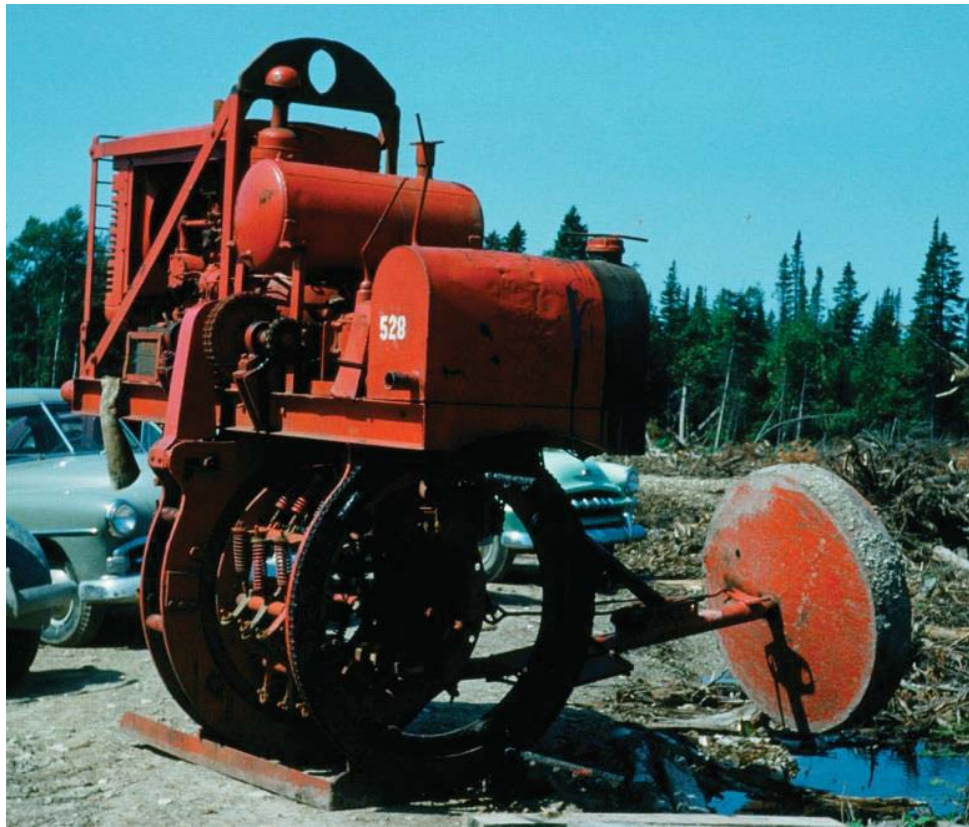
Figure 1. Trugen Photo of Pipe Cleaning Machine (00010370013.tif)

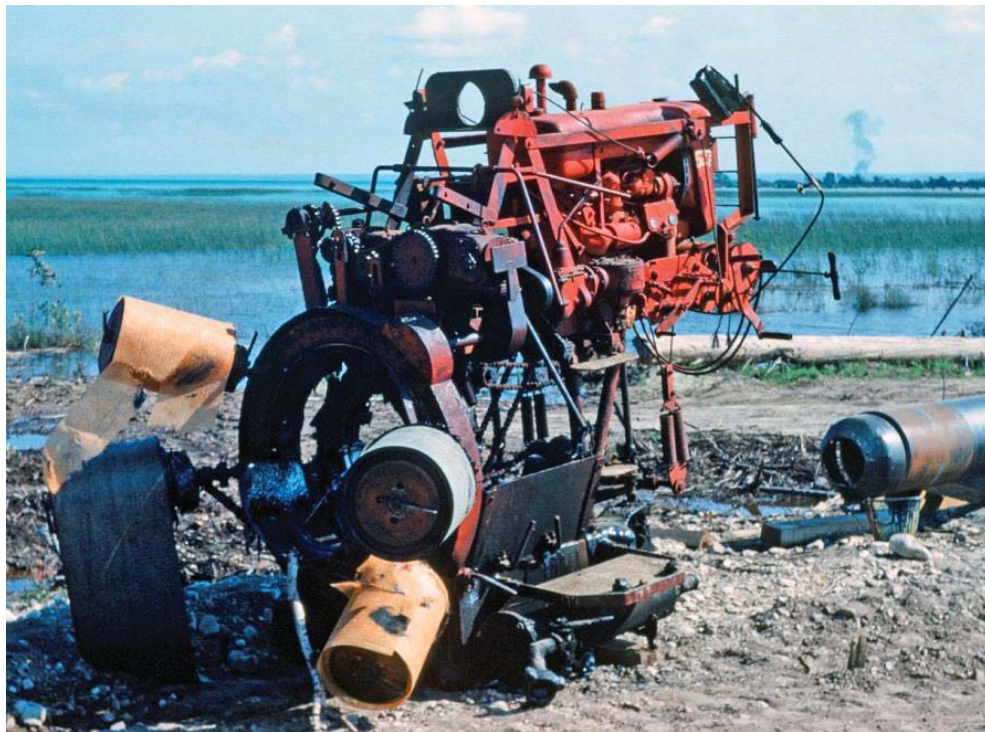
Figure 2. Trugen Photo of Pipe Wrapping Machine (00010370012.tif)

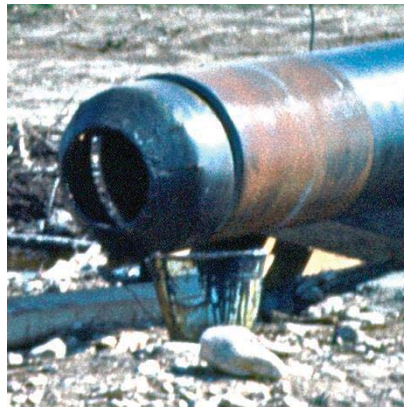
Figure 3. Detail Enlarged from Trugen Photo of Pipe Wrapping Machine Showing Wrapped Pipe (00010370012.tif)

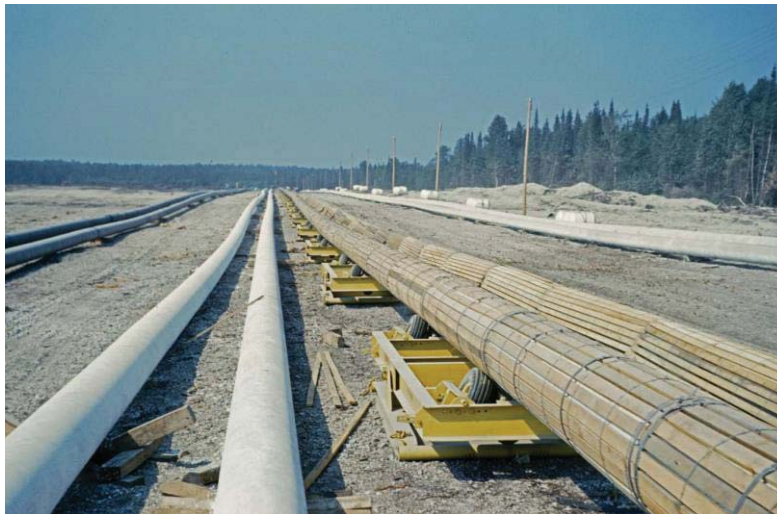
Figure 4. Trugen Photo of Pipe Stockyard (00010370011.tif)

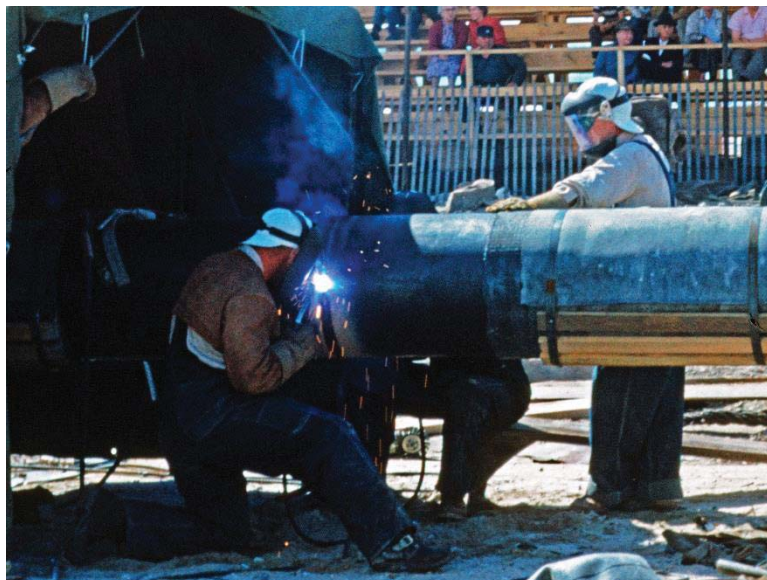
Figure 5. Trugen Photo of Pipe String Assembly Welding (00010370005.tif)

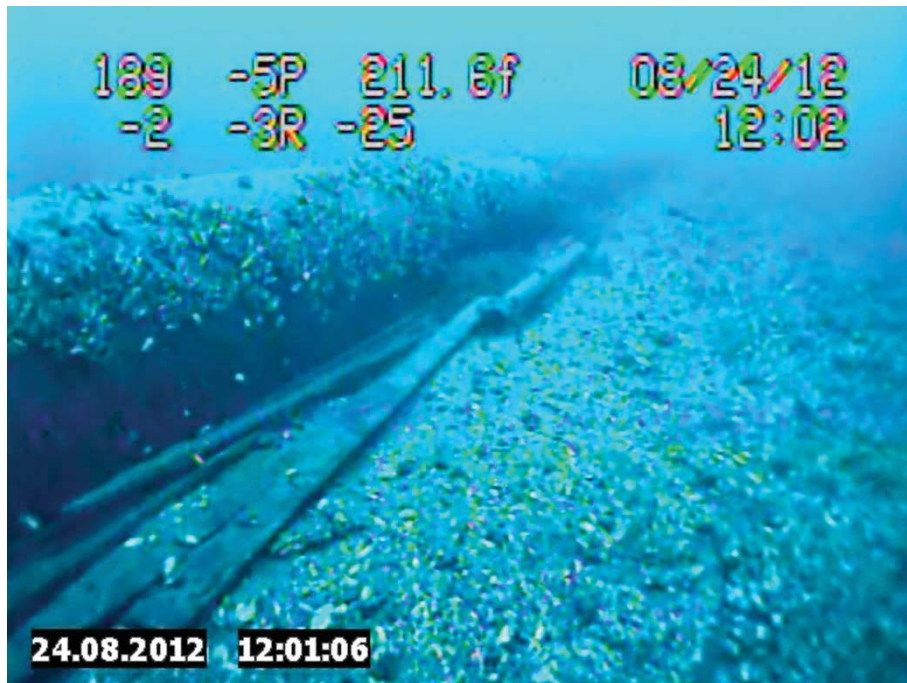
The 1" x 4" wooden slats that were supposed to encircle the pipe and prevent coating abrasion and point load protection were found to be largely missing in 1964. Two as built drawings of the pipeline (Appendix 1, References 4 and 5) show notations that indicate most of the slats were damaged during the pipe laying operation. Figure 6 is a photograph clipped from the Enbridge 2012 underwater inspection video of Line 5 that, typically, shows these slats lying on the bottom surrounding the pipe. A review of all the video from the 2012 inspection does not show any slats encircling the line throughout its entire exposed length.

Figure 6. Photo Clipped from Enbridge 2012 Underwater Inspection Video of the West Line Taken on 8/24/2012 at 12:01:06 Showing Detached Slats.

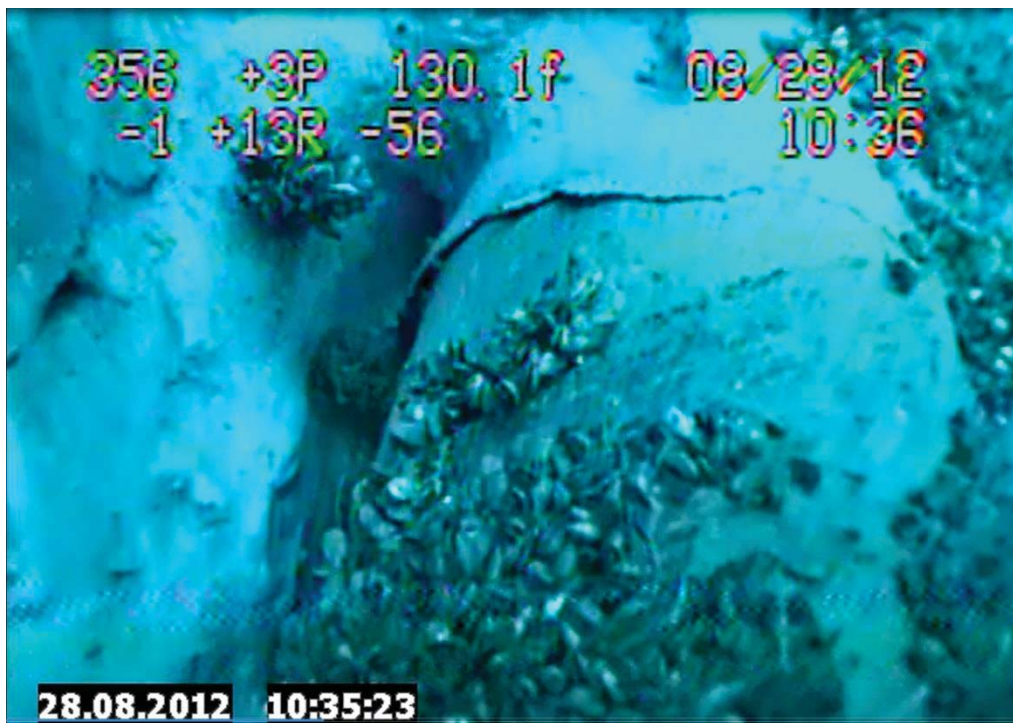
Judging the condition of the asphalt enamel saturated glass fiber coating system is difficult because the entirety of Line 5 is encrusted with biofouling comprised of mussels, algae and sediment. Bill Scheuette, Hydrographics Manager for Veolia ES Special Services, Inc. noted in his report⁷ to Enbridge following his firm's 2007 underwater inspection "The exposed portion of the pipeline is heavily covered in zebra mussel growth, making a detailed analysis of the coating and actual pipe condition impossible." Figures 7, 8, 9, 10 and 11 are clipped from Enbridge's 2012 underwater inspection video and show features where it appears the coating is either partially or totally missing or disbonded from the pipe. Figure 11 is especially interesting because it was taken at one of the few times the survey vehicle turned on its lights revealing true color. Video taken below about 60 feet deep only shows blue/grey monochrome images because red light is entirely filtered out by the water at this depth. There may be another interpretations of Figure 11, but it appears to this author as if the coating is compromised in many areas and the pipe appears rusty with apparent pitting corrosion when viewed in true color.

Figure 7. Photo Clipped from Enbridge 2012 Underwater Inspection Video of the East Line Taken on 8/28/2012 at 10:35:23 Showing Missing and Disbonded Coating

Based on knowledge of the coating system used on Line 5 and the photographic evidence presented in Figures 7-11, the asphalt enamel based coating system on Enbridge Line 5 under the Straits is compromised or missing on many areas of the pipe. Because of biofouling and the lack of true color underwater survey videos, it is impossible to judge how much of the coating system is compromised. It is known that the 1" x 4" wooden slats, designed to protect from point loads and abrasion, are entirely missing. Cathodic protection survey data, which could be interpreted to give an indication of the integrity of this electrically shielded coating system, is not publically available.

Even though the pipe used in Line 5 under the Straits has very thick walls and is a favorable alloy, it is not immune to corrosion and stress corrosion cracking. The biofouling on the pipe has been documented⁹ to produce a very corrosive environment in some situations. It is clear that the coating system on Line 5 under the Straits has exceeded its useful life and no longer provides the level of corrosion protection expected by the original designers. A full study of the integrity of the coating system and the impact of biofouling on Line 5 is required as an integral part of any fitness for service evaluation made of this pipe. Recommendations as to the design of this study are beyond the scope of this Appendix but would involve biofouling sampling and characterization, coating sampling and characterization, pipeline cleaning and inspection and other work intended to elucidate the exact condition of the coating on Enbridge Line 5 under the Straits of Mackinac. In this study, special attention should be paid to the

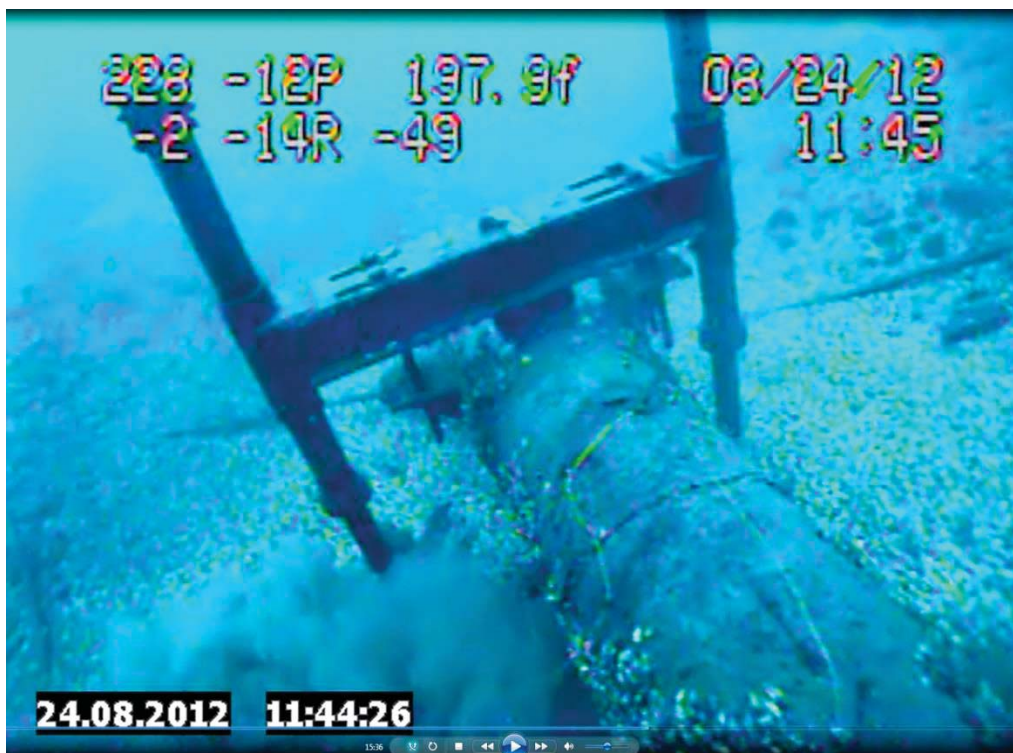
Figure 8. Photo Clipped from Enbridge 2012 Underwater Inspection Video of the East Line Taken on 8/24/2012 at 11:44:26 Showing Missing and Disbonded Coating

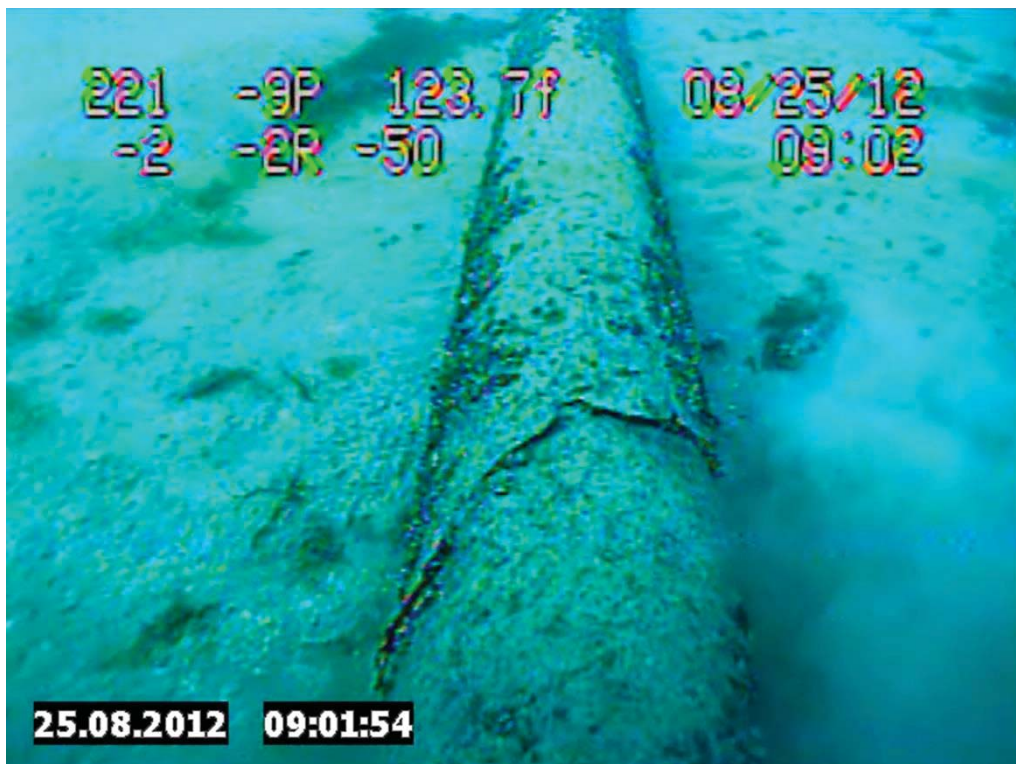
Figure 9. Photo Clipped from Enbridge 2012 Underwater Inspection Video of the East Line Taken on 8/25/2012 at 09:01:54 Showing Missing and Disbonded Coating

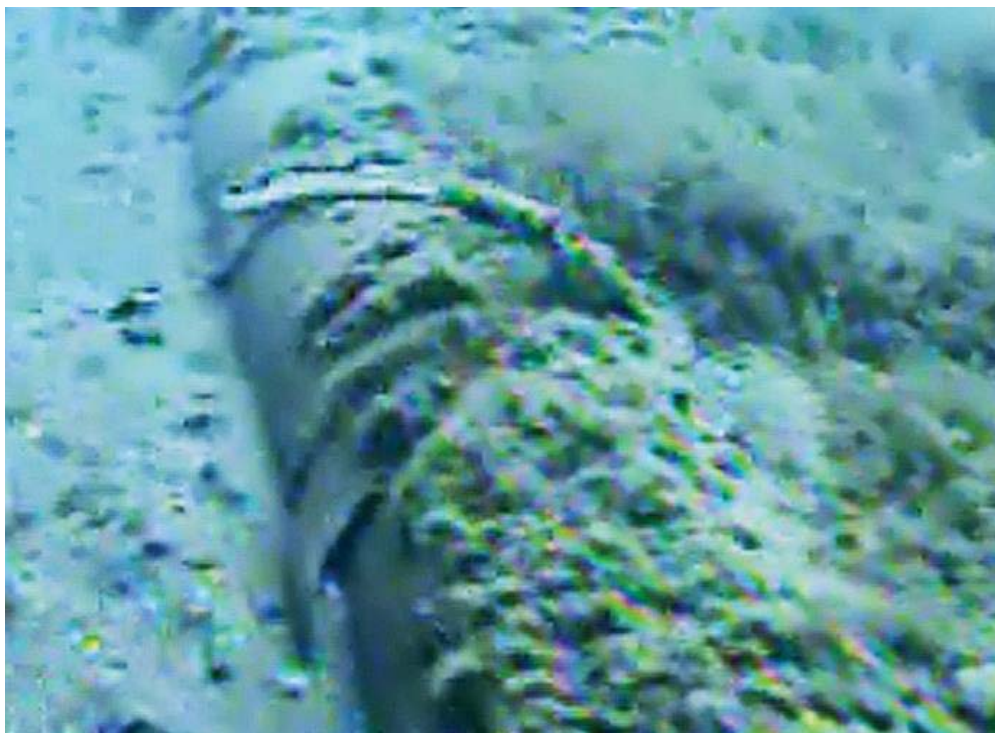
Figure 10. Detail from Photo Clipped from Enbridge 2012 Underwater Inspection Video of the West Line Taken on 8/25/2012 at 15:58:44 Showing Disbonded Coating and Broken Band

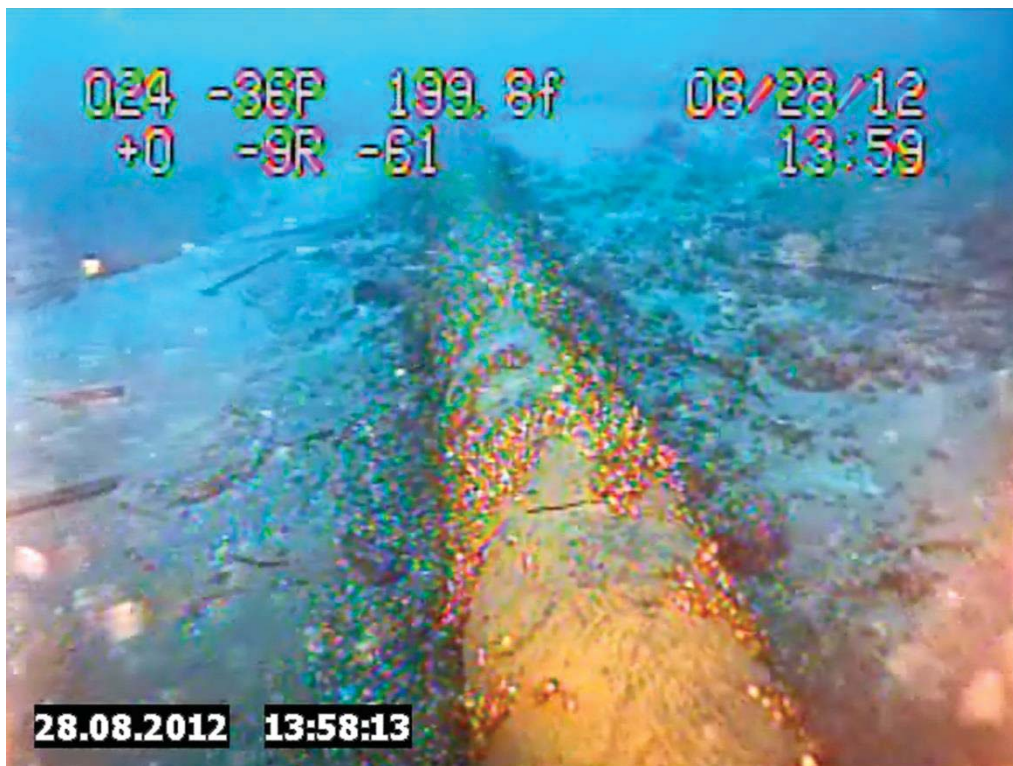
Figure 11. True Color Photo Clipped from Enbridge 2012 Underwater Inspection Video of the East Line Taken on 8/28/2012 at 13:58:13 Showing Missing and Disbonded Coating and Rusty Coloration of Pipe with Apparent Pitting Corrosion

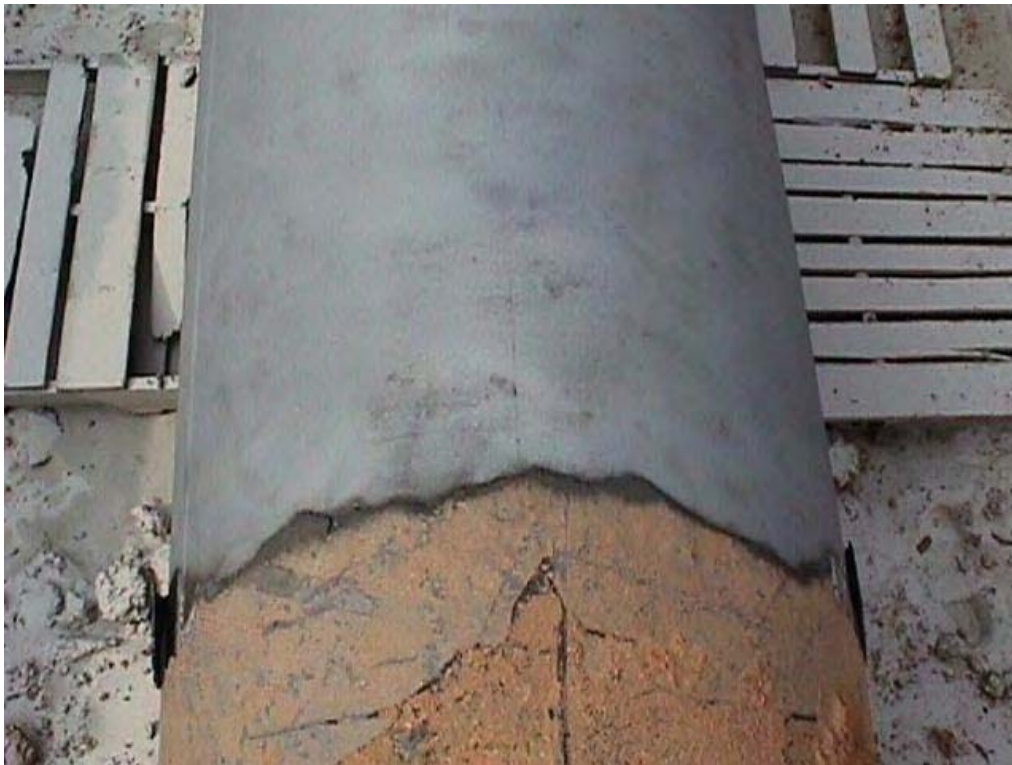
Figure 12. Typical Corrosion Found Under a Disbonded Coating as Reveled by Light Abrasive Blasting
